Bridger Pines Complaint Site Visit 09/20/2012

Report Date 09/21/12

Gallatin City County Health Department Thomas Moore, RS (406-582-3120)

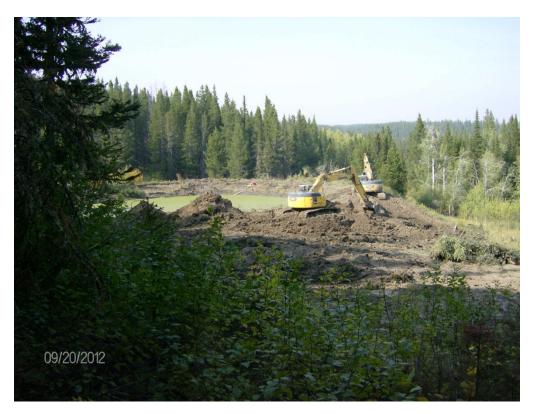
a. The complainant and I walked below the lagoon area and did not find any discharge (large or small) other than a dewatering pump on the edge of the pond. The engineer states the green color of the pond is due to an algae (duckweed) bloom. Two excavators were working on the face of the pond. See photo 1 below.

Our route took us to the right of the excavators (in the photo), along the bottom, to the small red object visible on the far edge of the pond. This was the area of a dewatering pump that had a 4 inch collapsible line pulling water up and out of the pond putting it into the trees below. Again, there was no discharge or wet ground currently noted below the lagoon.

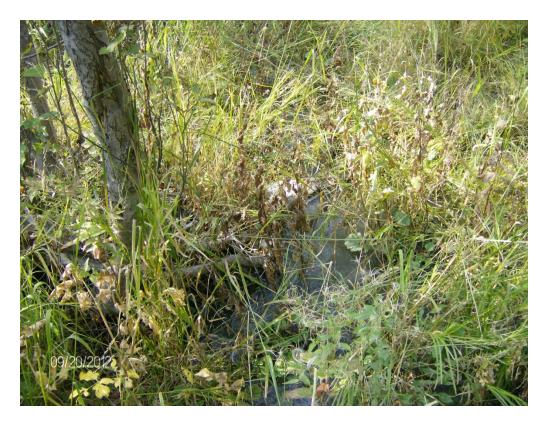
- b. The pump discharge caused a small waterway (a little larger than 'step across') that began in the trees noted to the right of the excavators above. The water appeared brown and had an odor, with some organic foam. See photo 2 below.
- c. We followed the discharge approximately one-quarter mile. It would alternately spread out into meadows, forming marshy areas with no discernible flow, then collect in narrow channels with evident movement. About 1/3 mile below the lagoon it collected at the edge of an abandoned road, where it moved until it came to a culvert, crossed the road and restarted movement down slope again in an old evident creek channel that likely carries snow runoff. We did not follow further but that creek channel continued in the direction of Bridger Creek below.

Photo 2: Pump flow discharge showing size and foam (visible in the center of photo).
